APPROACHES FOR TENSILE TESTING OF BRAIDED COMPOSITES

Gary D. Roberts and Jonathan A. Salem
NASA Glenn Research Center, Cleveland, Ohio

Braiding approach for composite fan cases

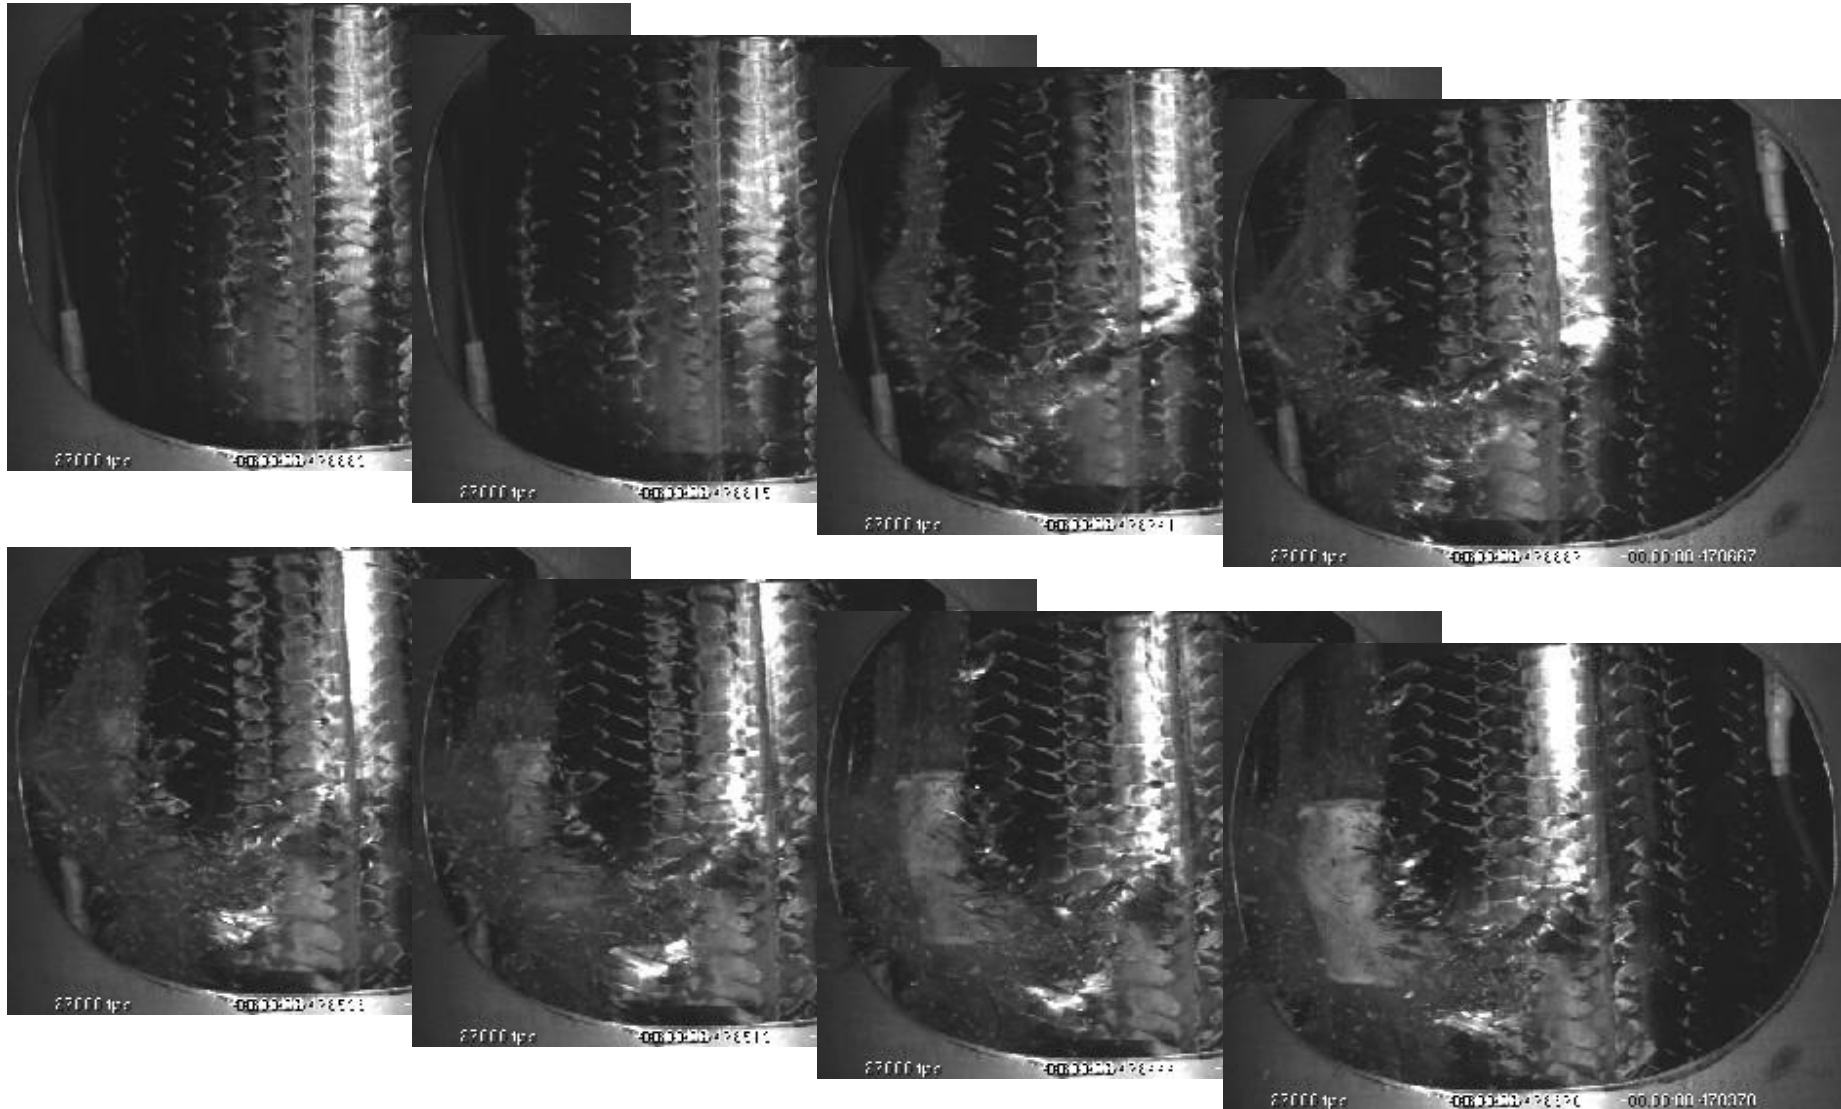
Partial internal pressurization test – image sequence

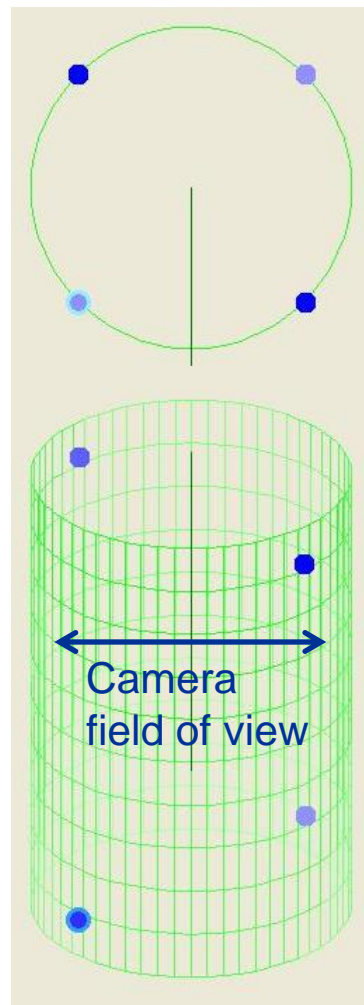
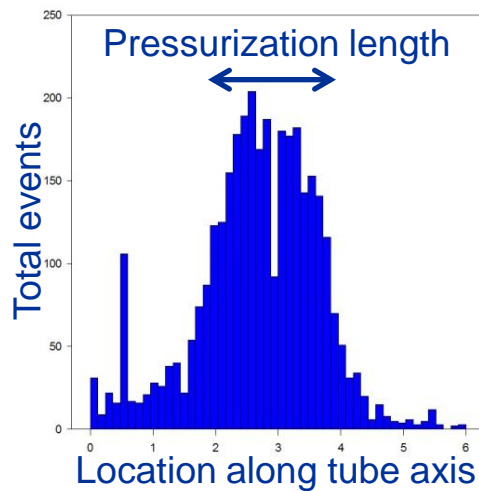
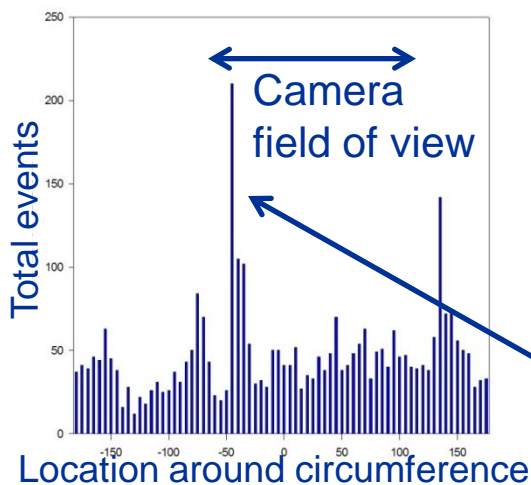
Acoustic emission during partial internal pressurization test

Sensor Locations

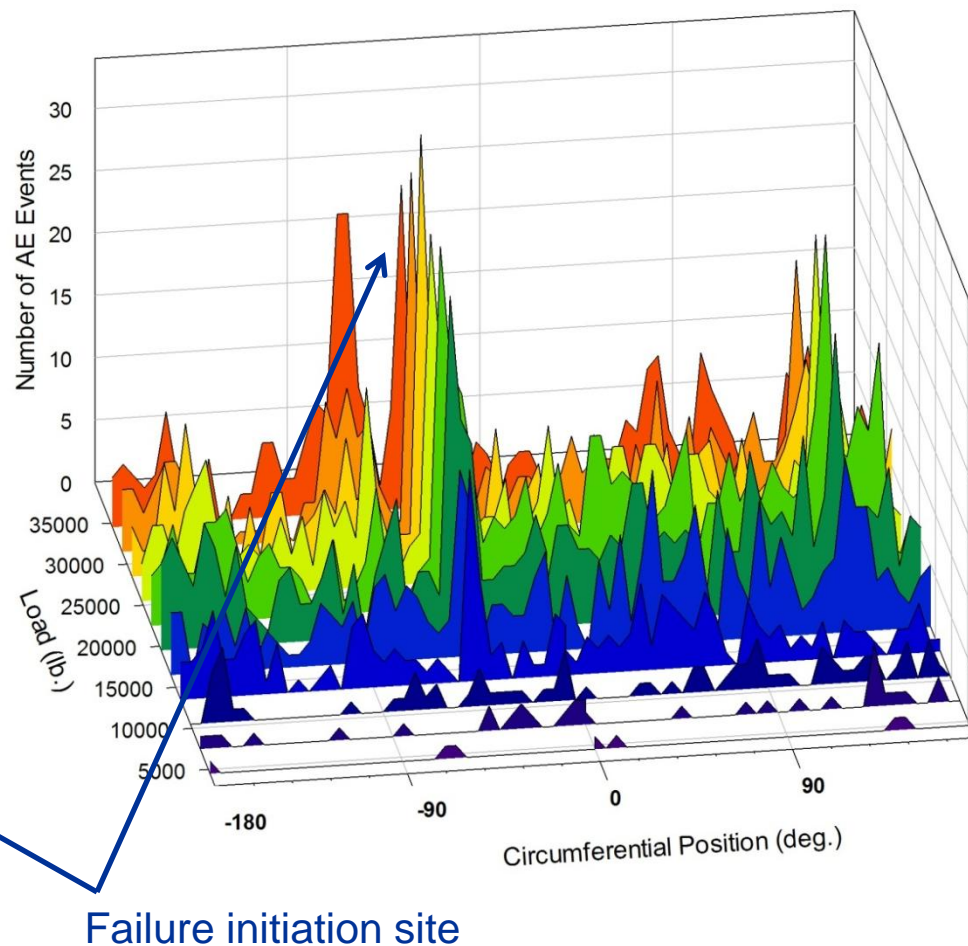
Events during 3000 lb load increments
